Onze Molen, Durbanville

Report on Restoration Work

February 2011

2 SNAG LIST

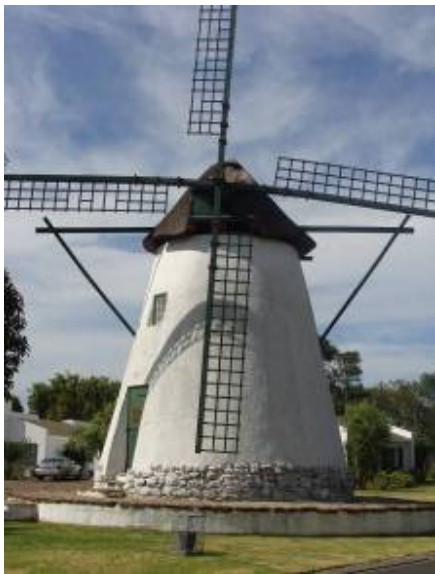
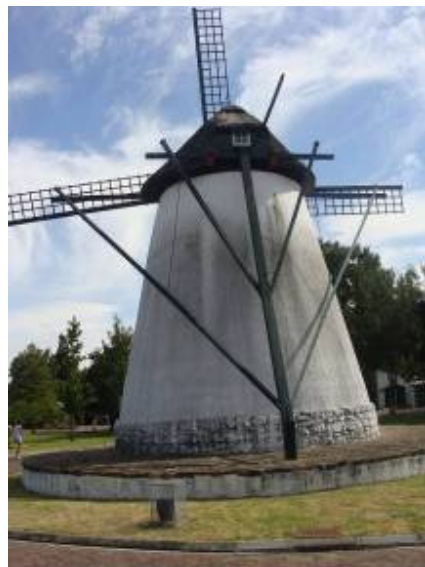
1. Lime-washing the exterior walls

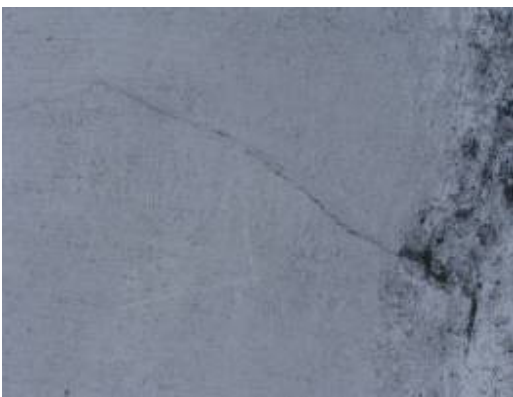
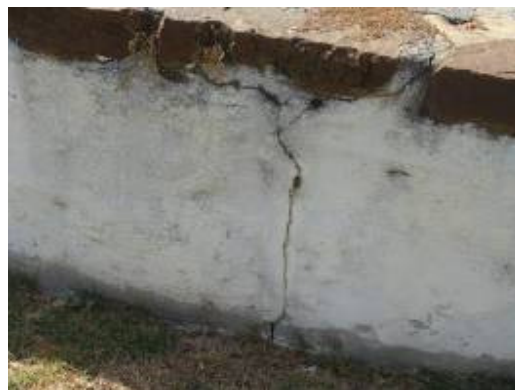
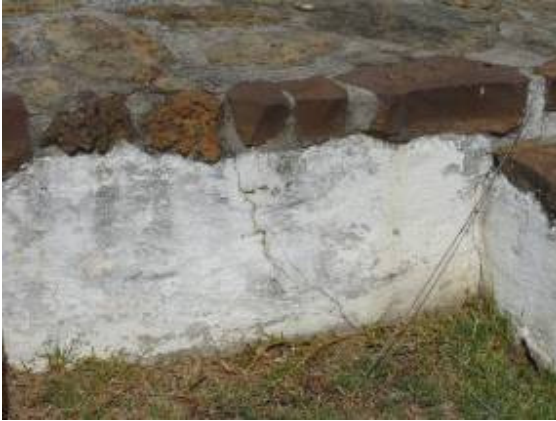
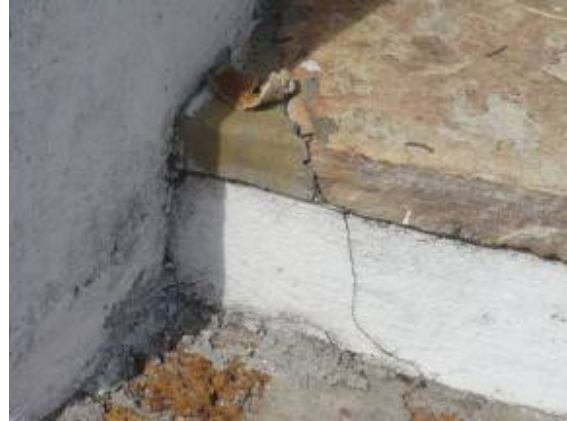
2. Repair hairline cracks which have formed in the walls and the structural cracks in the platform base and steps.

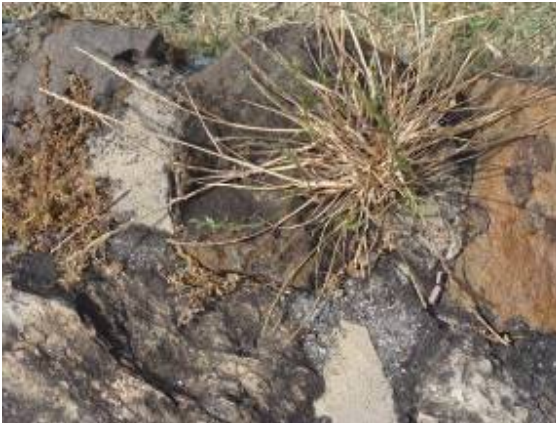
3. The platform base needs to be treated with a pesticide to remove plant growth which is compromising the structure and is probably the cause for the cracks in the base

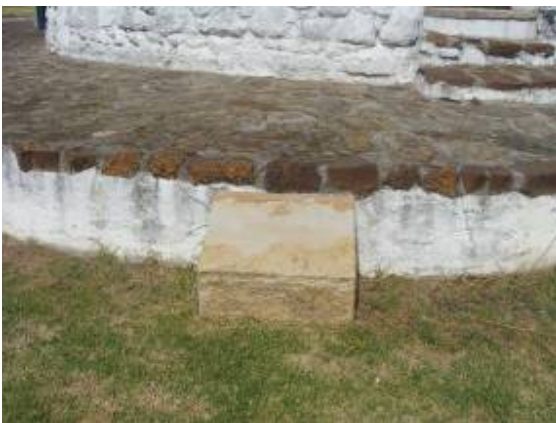
4. Replace/ install a plaque on the plinth which has been erected in front of the mill

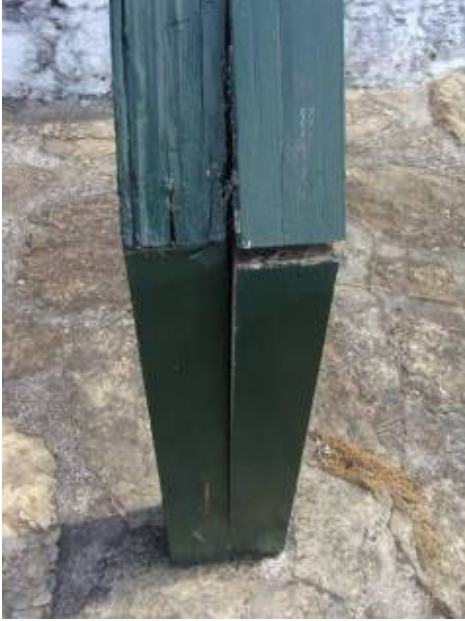
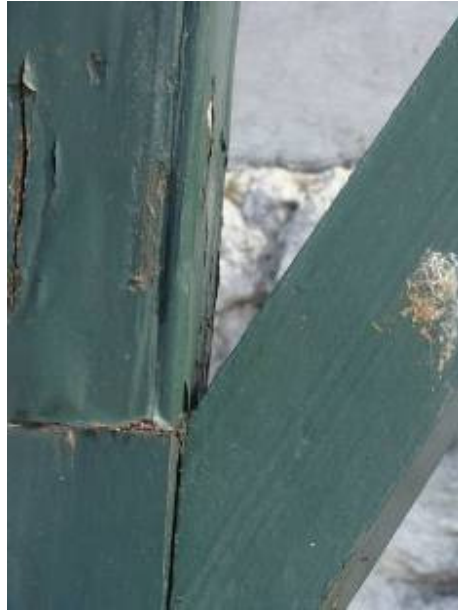
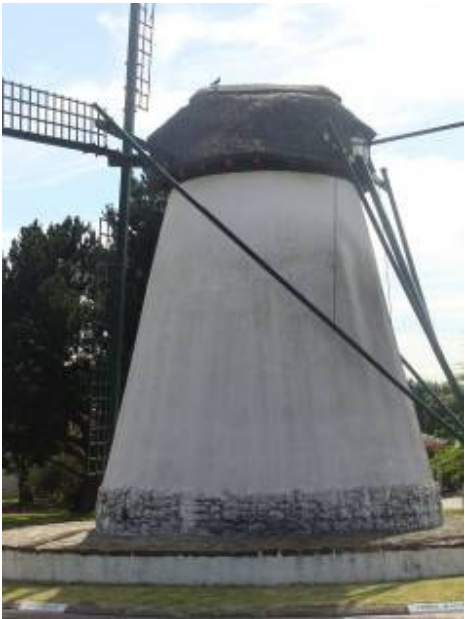
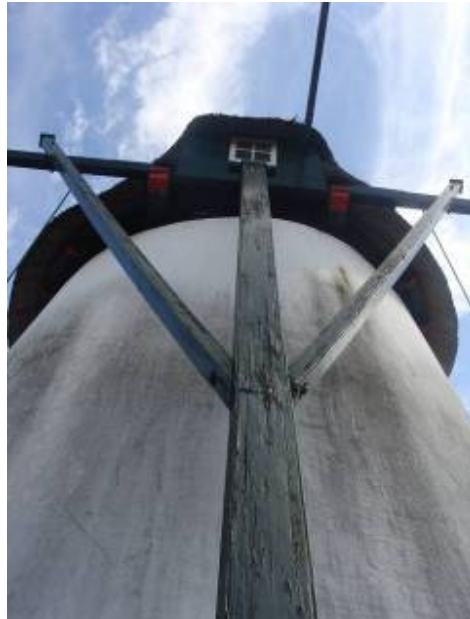
1. Structural maintenance for safety of both the exterior and interior machinery and wood work. The timber support structure for the fins needs to be repaired/ replaced and made safe.
2. Repaint external timber work

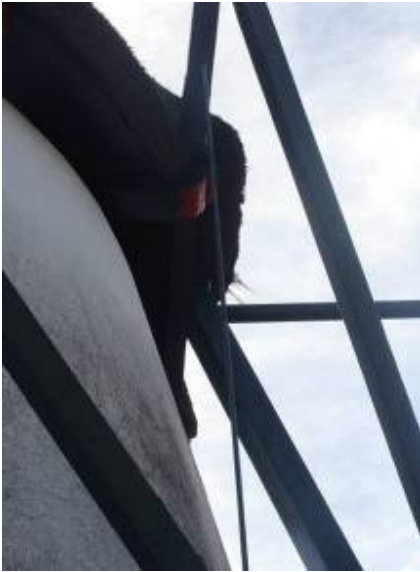
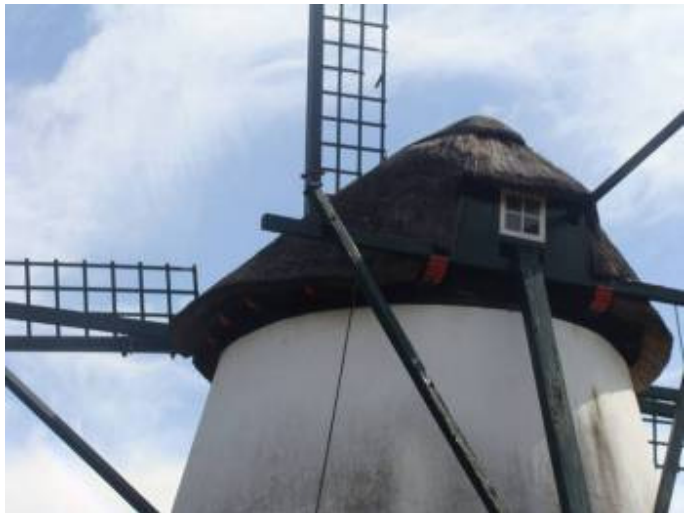
1. Check Roof structure
2. Thatch needs replacing, has been ripped out by birds/ weather
3. Check that bird proofing is all in place

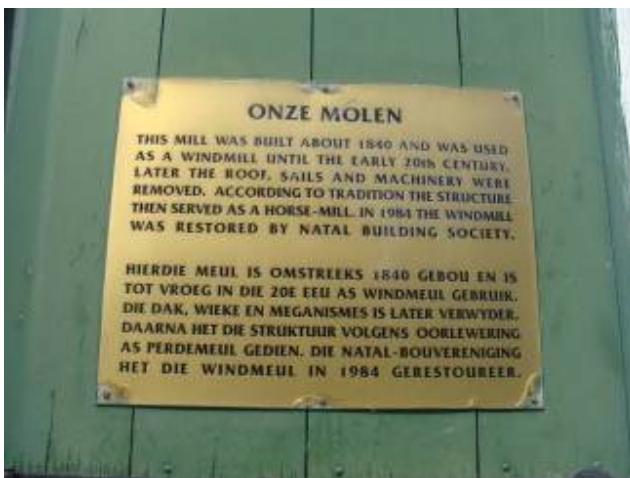
1. Checking and Painting of door and windows. All glazing seems in order, however check catches and locking mechanisms
2. Brass plaque on wall has been damaged on the edges

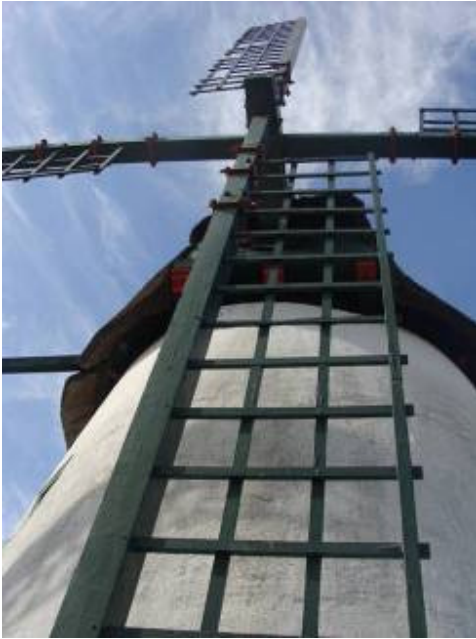
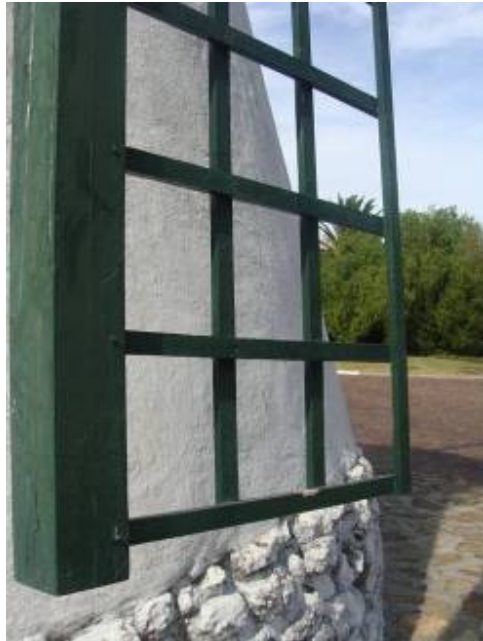
1. Replace sails
2. Repair fins and replace missing timber spokes
3. Replace damaged timber and repaint all external woodwork
4. check structure for safety
